MEMORANDUM

Date: September 28, 2020

Re: Mill Pond Outfall Assessment

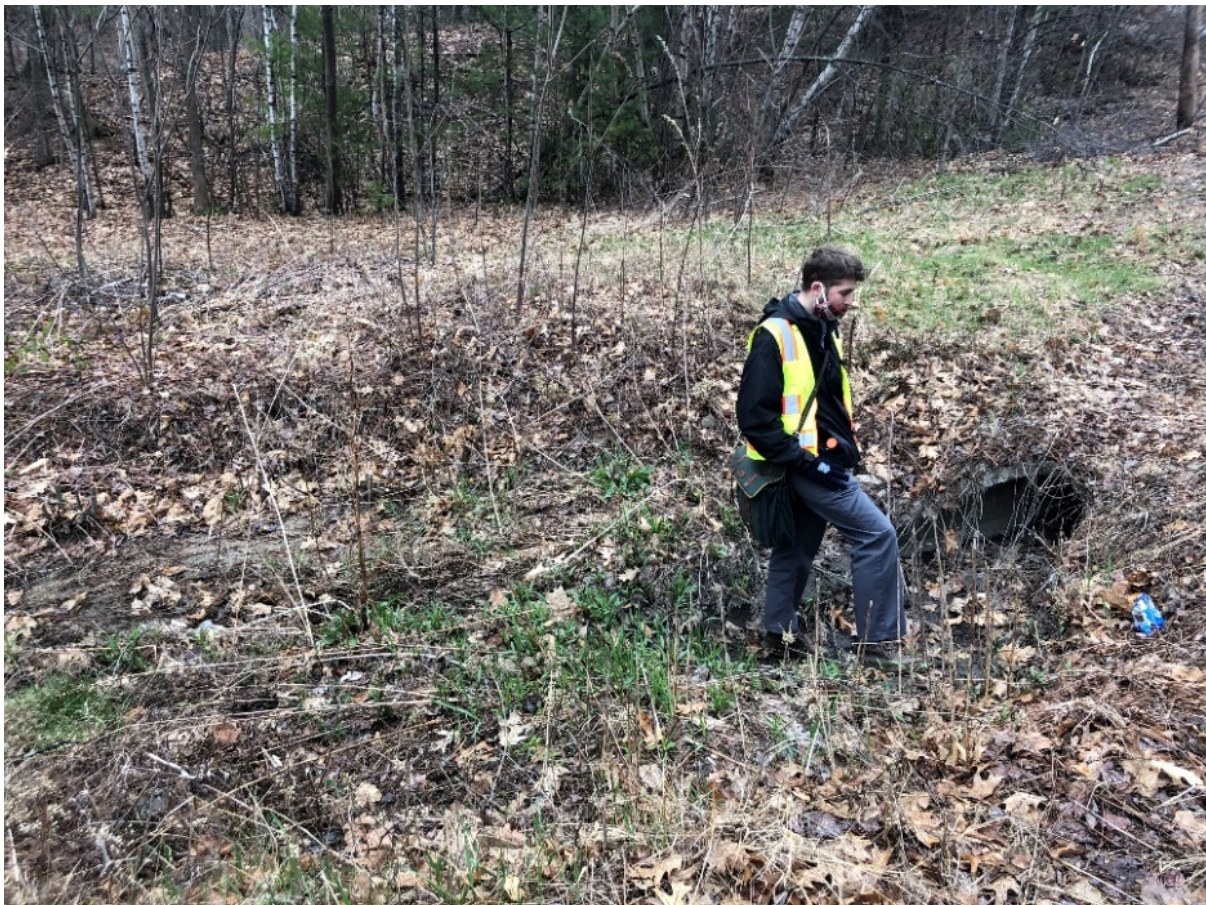
Photo 1. Outfall 1 is clogged with leaves and is set lower than the swale leading to Mill Pond.

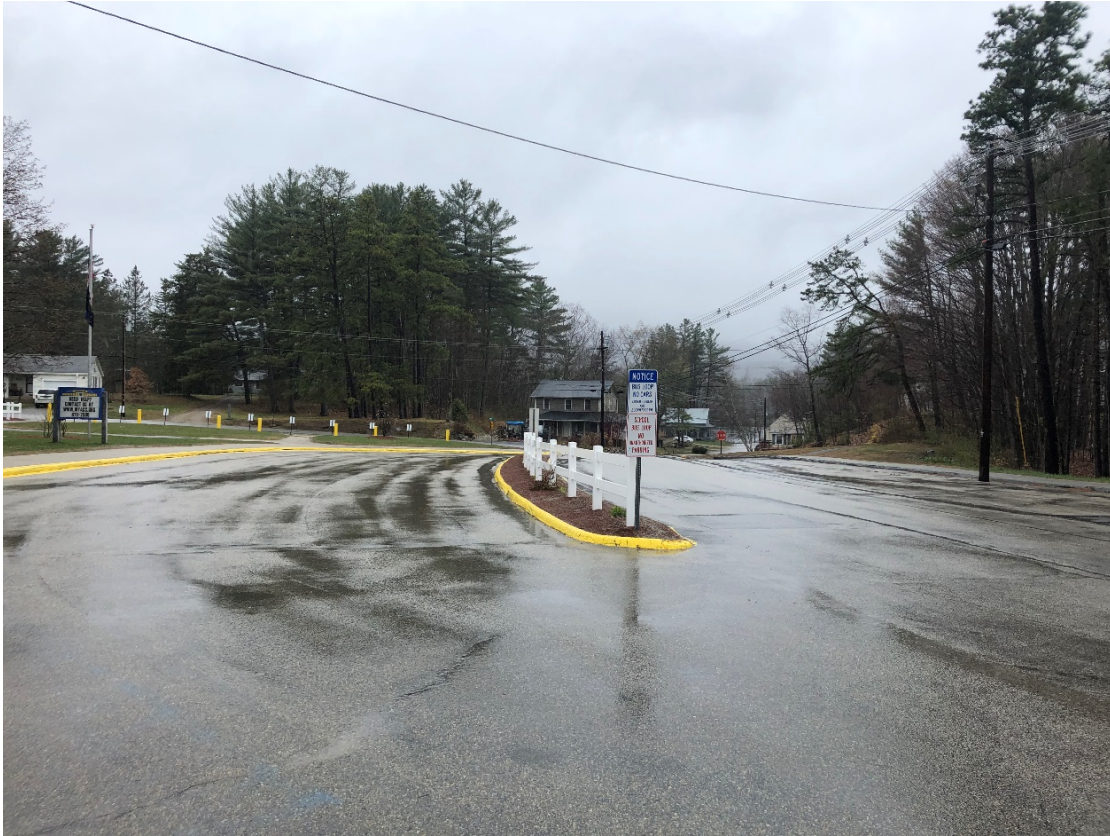
Photo 2. Bus drop off/pick up area at Alton Central School. Road width exceeds 30 horizontal feet and provides an opportunity for pavement reduction and simple flow-in/flow-out bioswale system.

HW recommends analyzing the traffic patterns and turning radius needs to determine the extent of pavement removal along School Street and at the Bus drop-off zone. The existing landscape island containing the white split-rail fence may be retrofitted into a simple flow-in-flow-out bioswale system to allow for soil filtration and plant uptake.

By embracing the existing stormwater flow path(s), the design and implementation of BMPs will minimize earthwork expenses and utilize existing controls to convey larger (>1") storm events. HW recommends the installation of a flow-in/flow-out bioswale pilot project at the drop-off area in front of the Alton Central School. This solution incorporates both a reduction of impervious cover (pavement) and stormwater treatment up to the water quality volume (WQv). Beyond

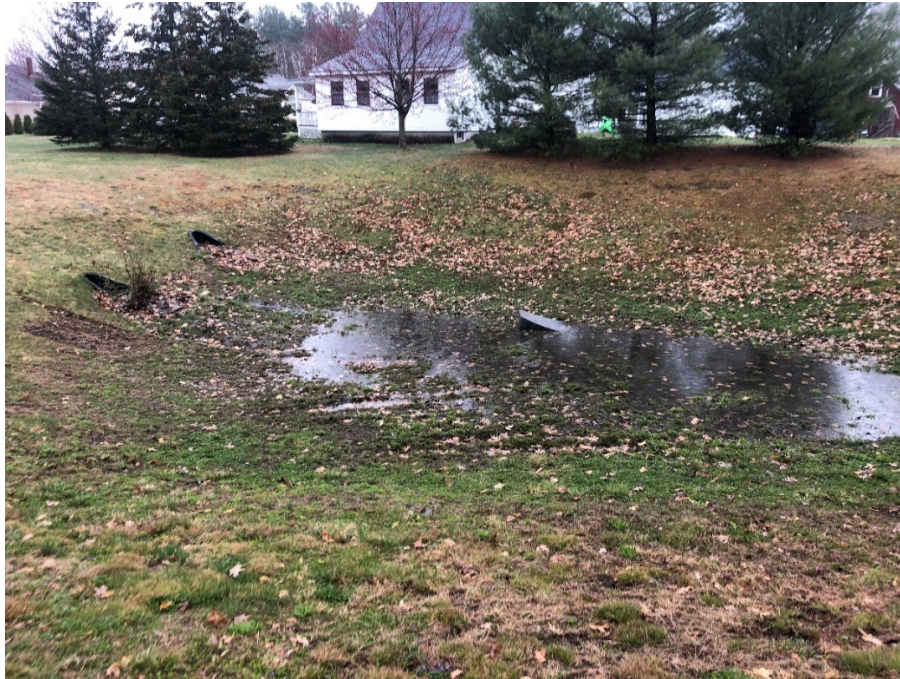
Photo 3. Retention pond at Profile Bank manages stormwater for DA3

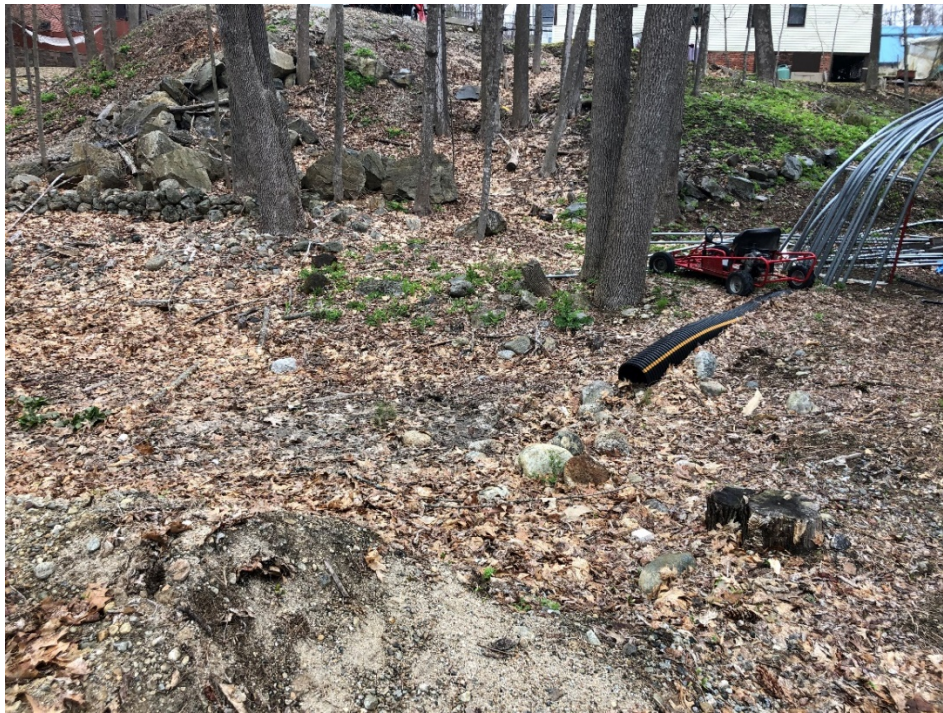
Photo 4. Outfall 4 is directed to a natural depression via a pipe.

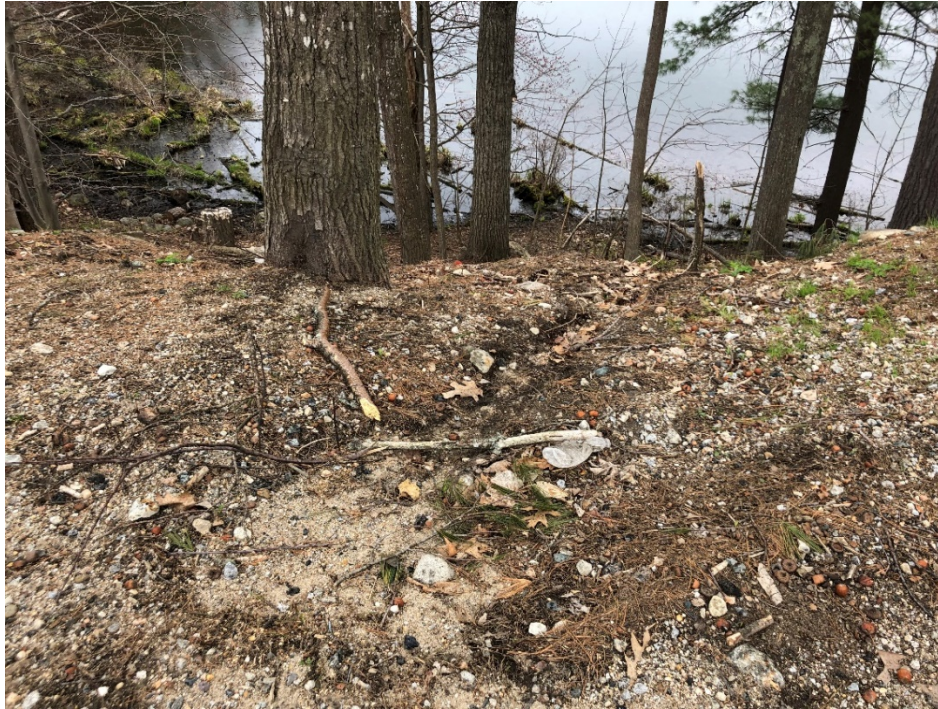
Erosion was not observed at Outfall 4. Erosion from surface flow was observed at the top of bank behind the existing parking lot / stockpile area in the rear of the building. A channel gully leading to Mill Pond is forming as a result of channelized flow. The slope down-gradient of the laundromat parking lot / stockpile area is extremely steep (2:1), much like the terrain throughout the eastern edge of Mill Pond.

Photo 5. Channel gully forming at top of bank flowing towards Mill Pond.

With the property owner's consent, HW recommends the installation of a sediment forebay and rain garden at the point of erosion. The rain garden should be designed to accommodate the existing use(s) and sized to treat the WQv. HW recommends that the rain garden be designed with side-wall filter fabric to prevent seepage and a level spreader as the primary overflow device to dissipate velocity/channelized flow to reduce bank erosion.

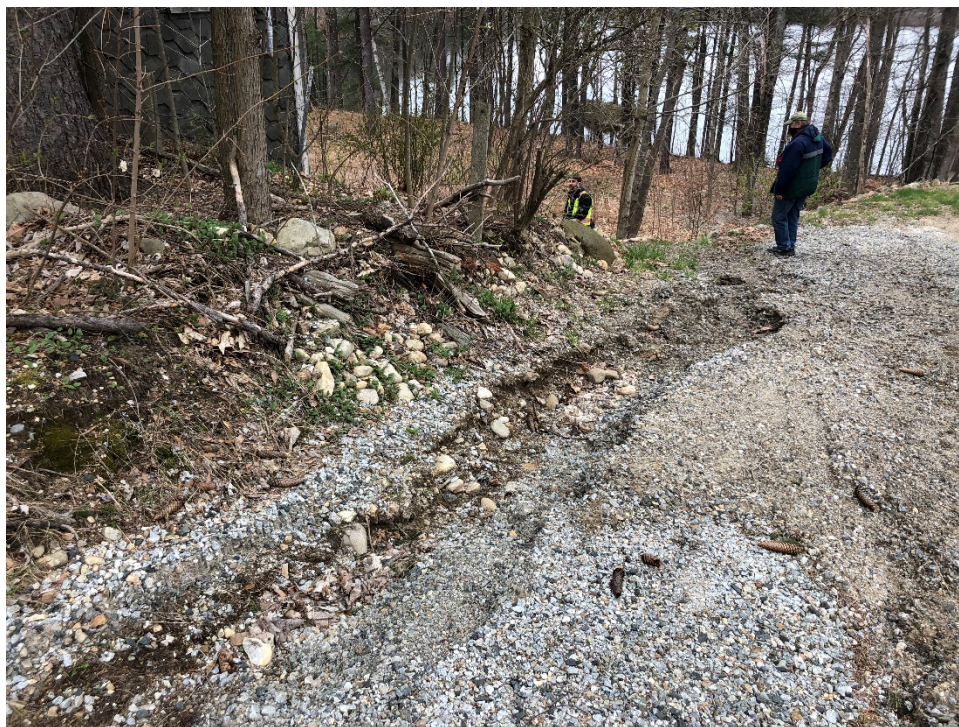
Due to the existing topography of Main Street, stormwater runoff bypasses the existing catch basins that direct flow to Outfall 5. Instead, a majority of stormwater flows over the driveway of 189 Main Street, where severe channel erosion is present. Eroded material is washed down-gradient on to 177 Main Street where stormwater eventually flows through a simple swale system. The swale runs along the property boundary through the owner's backyard toward Mill Pond where minimal erosion/sedimentation is observed at the outflow. The swale is sufficient to manage the run-on that reaches the site. Visible erosion does not extend beyond the backyard of 189 Main Street. However, sediment transport is an immediate issue which may impact the swales performance long-term.

Photo 6. Severe channel erosion down the driveway of 189 Main Street towards Mill Pond.

The homeowner has proactively installed the swale system and trench drain to mitigate the adverse impacts of uncontrolled road runoff. HW recommends that the Town of Alton engage NHDOT to install a bituminous berm along the pavement edge of Rt. 11 to promote positive drainage into the existing catch basin.

Short-term, HW also recommends simple check-dams within the swale system, using naturally occurring materials (rocks), to dissipate velocity and prevent sediment from reaching Mill Pond. To avoid sediment wash-out, HW recommends the property owner investigate porous soil retention products (such as Ecoraster E40) and/or implement a shallow rain garden to intercept the road runoff currently causing the erosion. A short-term fix should be considered until NHDOT can install the bituminous berm along Route 11.

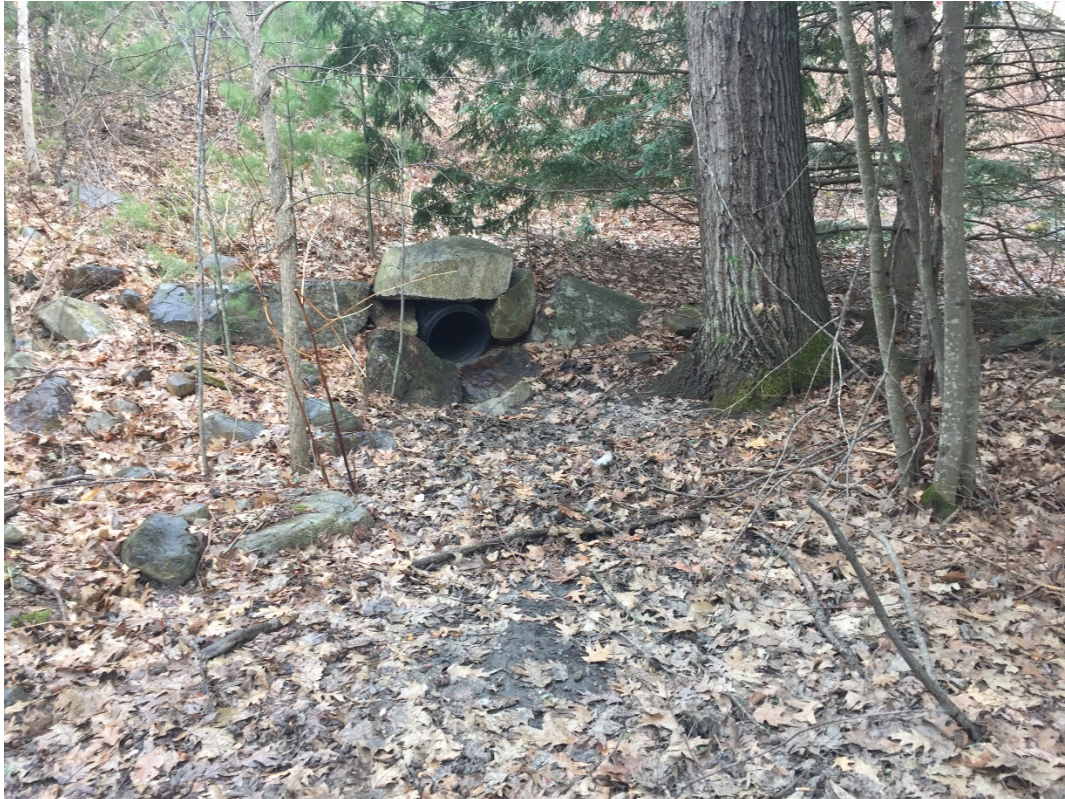
Photo 7. Outfall 6 discharging into shallow depression.

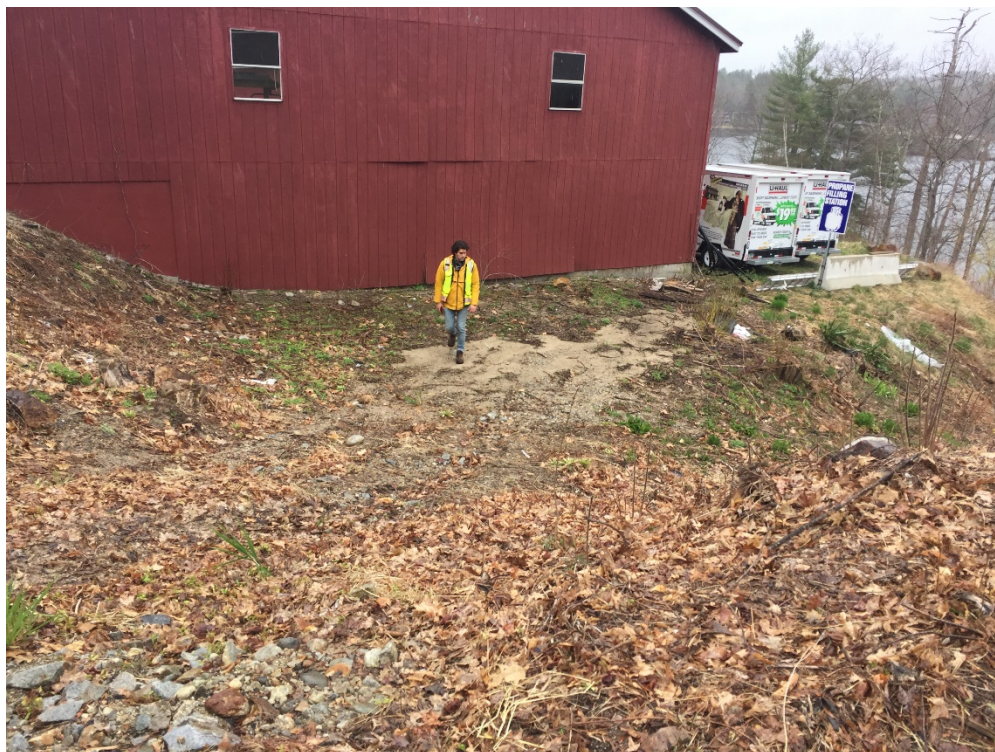
A portion of road runoff does bypass the existing catch basins on Main Street and flows into the gravel parking lot of the Garden Center. Runoff then flows down a gravel path behind the Garden Center, eroding the slope leading toward Mill Pond and Outfall 6. A patch of invasive Japanese Knotweed grows on the slope north of this runoff path and should be addressed in conjunction with any stormwater improvement work.

Photo 8. Sedimentation from road runoff draining towards Mill Pond.

Because of the steep and rocky terrain, site access to Outfall 6 will likely cause more harm than good. Therefore, HW recommends the placement of a sediment forebay and rain garden at the edge of the Garden Center parking lot to collect sediment, reduce erosion, and treat the WQv. To reduce sediment transport, HW recommends that the installation of permeable grass pavers in the Garden Center parking lot.

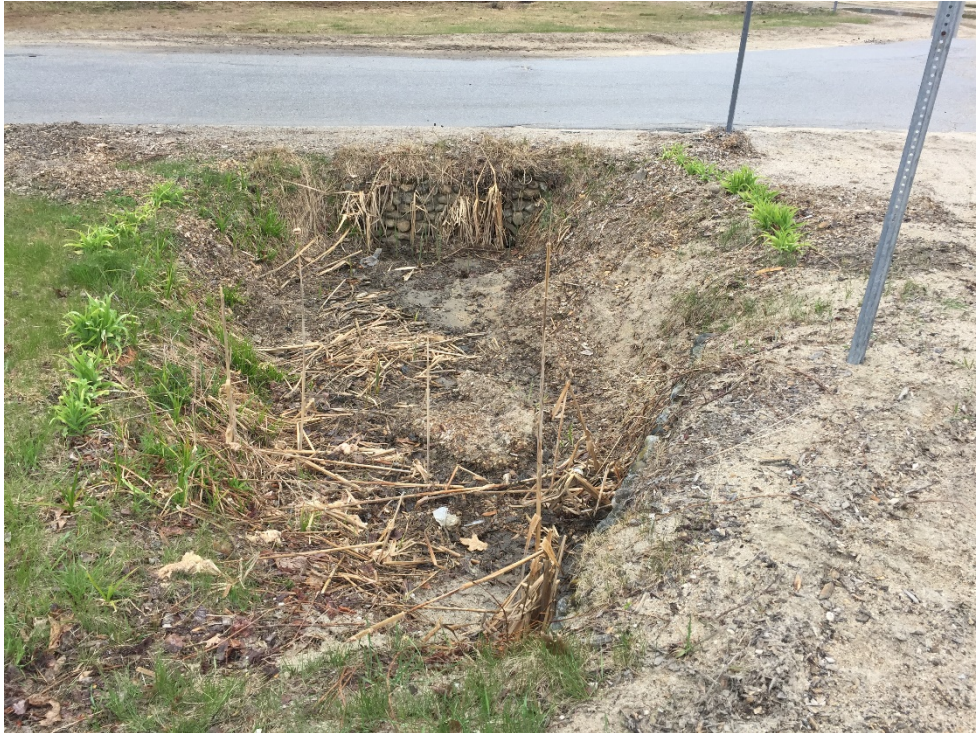
Stormwater is conveyed through a culvert to a depression at the intersection of Rt. 140 and Letter S Road, which is then conveyed to Outfall 10. The depression at the intersection has significant sediment buildup from neglected maintenance.

Photo 9. Landscape island at the intersection of Letter S Road and Frank C Gilman Hwy. Shallow depression conveys stormwater from the road and fire station to Outfall 10.

HW recommends establishing an operation and maintenance plan to clean the culverts and depression at the intersection of Letter S Road and Frank C Gilman Hwy. HW also recommends formalizing the depression at the intersection of Rt. 140 and Letter S Road by establishing a sediment trap between culverts to consolidate the maintenance burden.

With the available space, a “second-shelf” could be considered to increase treatment capacity. Given the spatial constraints and public safety, any stormwater controls within the intersection should be designed with a minimum freeboard of 12”. Wetland plants, such as cattails, should be planted within the expanded treatment area to allow for plant uptake and soil filtration.

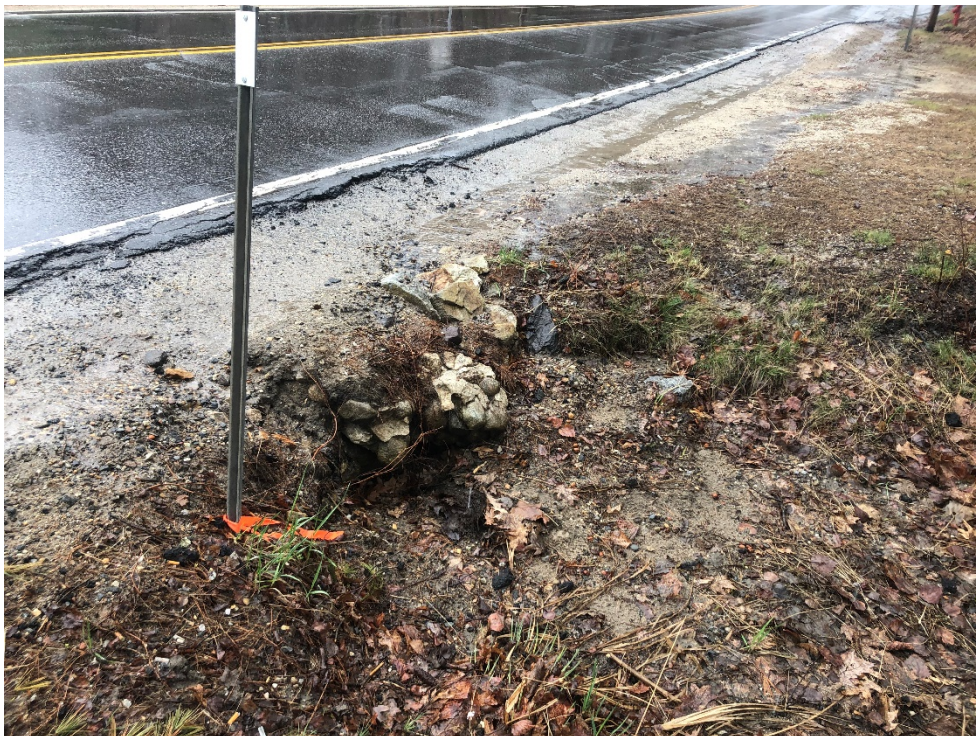
Outfall 11 collects minor amounts of road runoff along the southern edge of Frank C Gilman. Stormwater settles into a shallow depression located at 55 Frank C Gilman Hwy and a culvert connects the depression to Mill Pond. During HW's field visit, Outfall 11 was almost entirely clogged with leaf litter and miscellaneous debris.

Photo 10. Shallow depression conveys stormwater from Frank C Gilman Hwy to Mill Pond.

HW recommends routine maintenance be performed on an annual basis to remove sediments and road debris, such as salt, after the conclusion of winter maintenance practices. A trash rack may be considered at culvert inlet to prevent trash and larger debris from being transported by culverts.

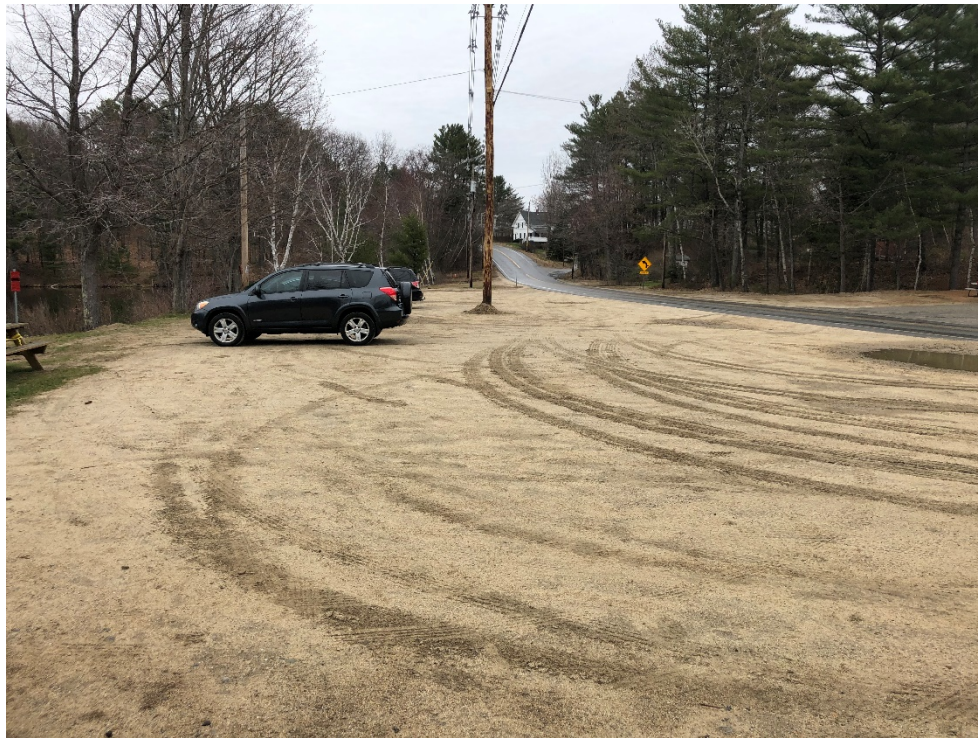
Photo 11. Loose aggregate parking area across from the Alton Fire Department.

To reduce erosion across the public parking area, HW recommends installing permeable pavers at the edge of pavement along Frank C Gilman Hwy to prevent overland flow across the parking area. The permeable paver swale should divert stormwater flows toward Outfall 1 or Outfall 10. Minor re-grading of the road shoulder and parking area will be required to promote positive drainage toward an existing point-source input.

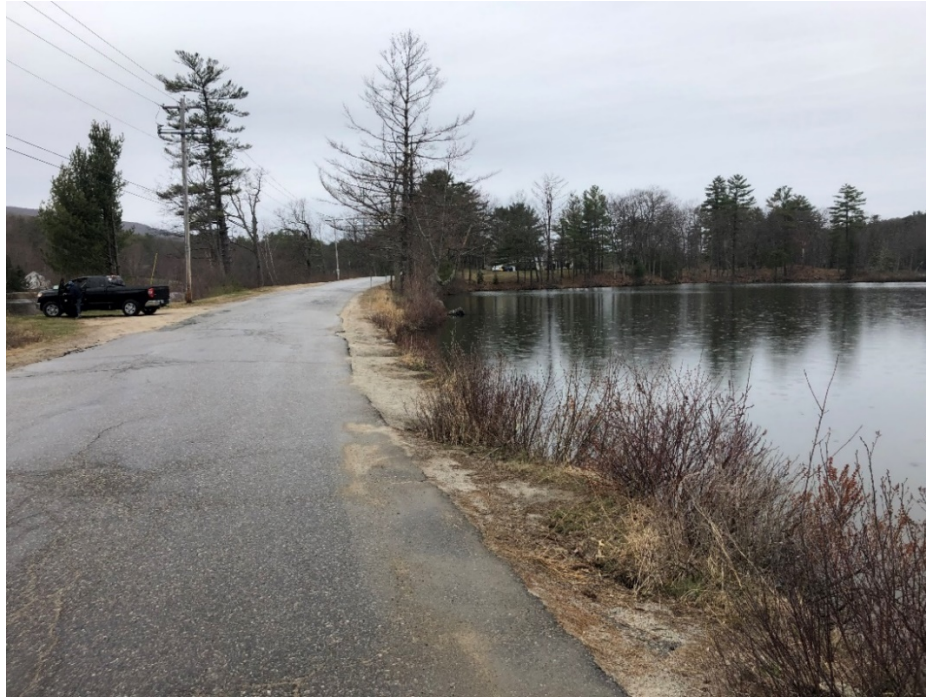
In addition to the three outfalls (#1, #10, #11), runoff along Rt.140 flows overland across a loose aggregate parking lot across the street from the Alton Fire Department. Non-point source stormwater inputs enter Mill Pond throughout DA12. As a result, bank stability is noticeably compromised. Implementing source, stormwater controls is paramount to providing water quality treatment prior to stormwater discharge into Mill Pond. Numerous gullies were observed between the parking lot and Mill Pond. Bank erosion and naturally occurring vegetation along Letter S Road is failing, which is due in large part to undefined parking and recreational uses.

Photo 12. Bank instability and erosion along Letter S Road.

HW recommends a more involved design approach be considered to better balance the recreational demands and environmental protection issues specific to the Letter S Road area.
