PHOTO LOG

**Town of Alton
Harmony Park—Tax Map 33 , Lot 84
Alton, New Hampshire
Photos Taken: September 2014**

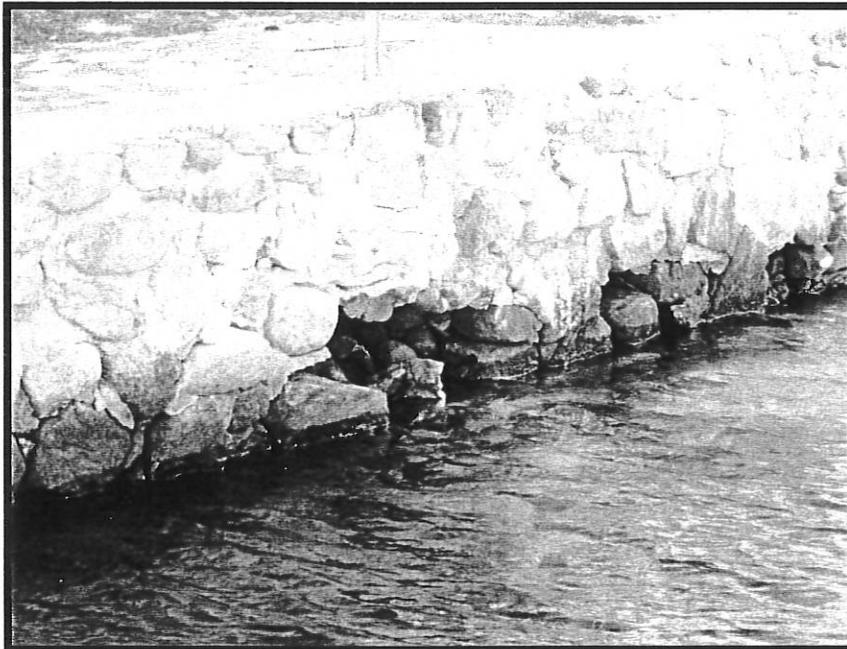
PHOTO 1:

This is the northwest end of the existing stone retaining wall which needs repair.

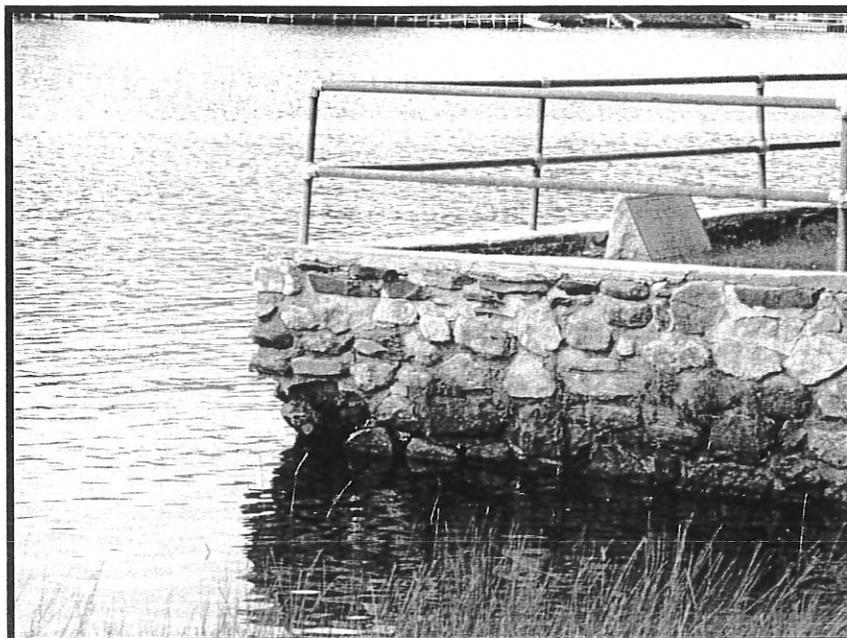
PHOTO 2:

This is a view of the south end of the existing retaining wall. Note the bottom of the corner has been eroded away.

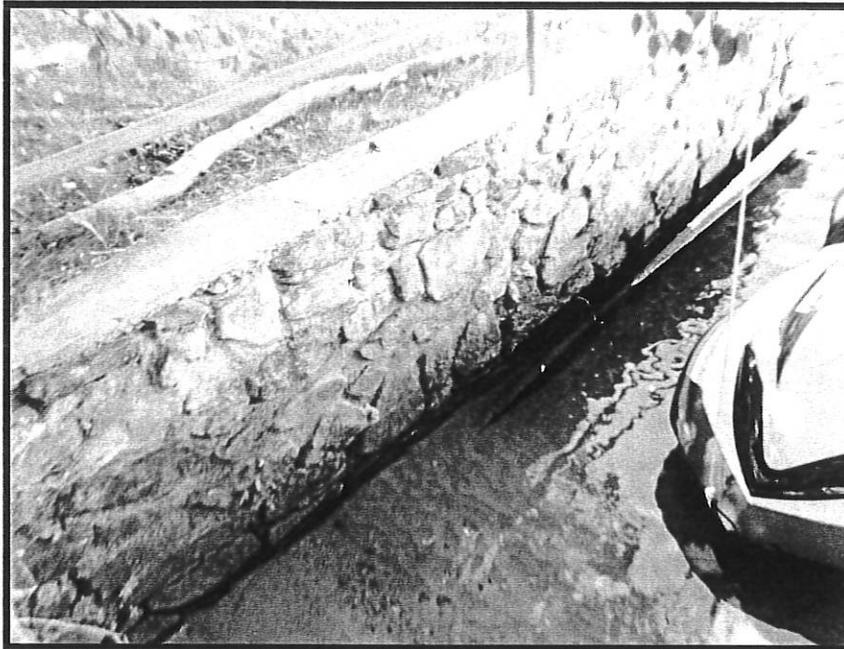
PHOTO 3:

This is the north end of the existing stone retaining wall. Repair will include re-pointing between the existing stones.

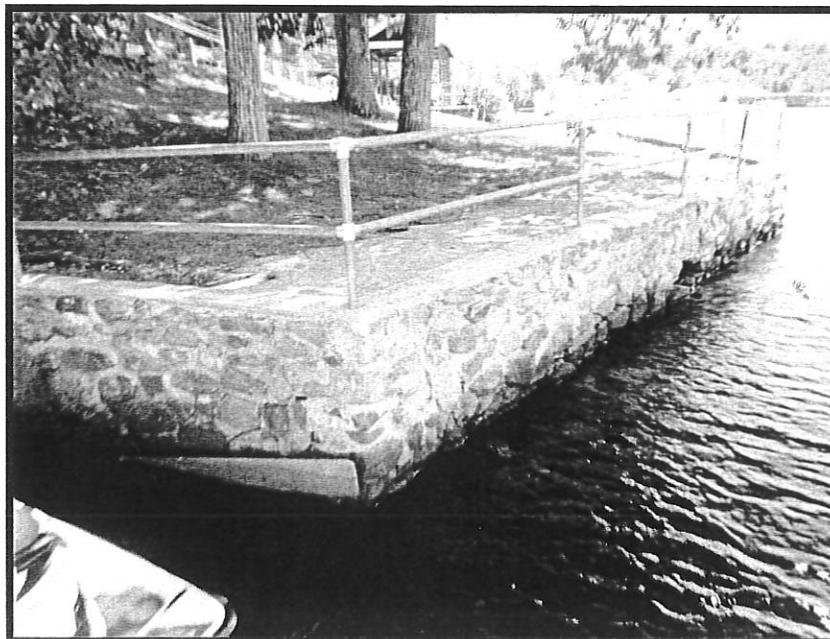
PHOTO 4:

This is a view of the northwest and north portions of the existing retaining wall, showing the erosion to the bottom of the wall.
